Manhole Inspection Summary

Manhole # S270__019MH

Insp Date: **5/1/08 11:40 AM**

Location Address: **1401 CLEVELAND sT**

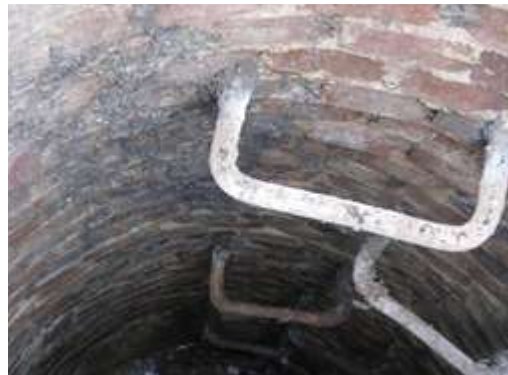
Defect 4

☒ **Evidence Of Surcharge** Depth: **7** (ft.) ☐ Active Surcharge Present

sign of surcharge

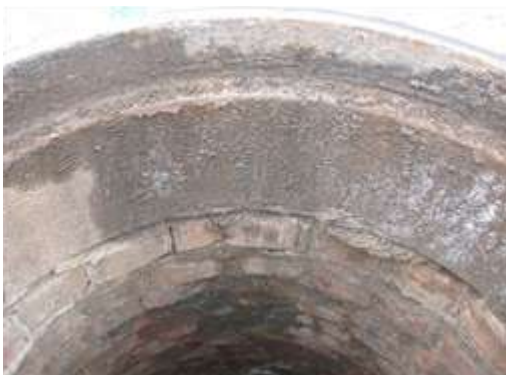
Defect 2

Infiltration: ☐ None ☒ **Joint** ☐ Cracks ☐ Mortar ☐ Roots ☐ Wall

infiltration Chimney

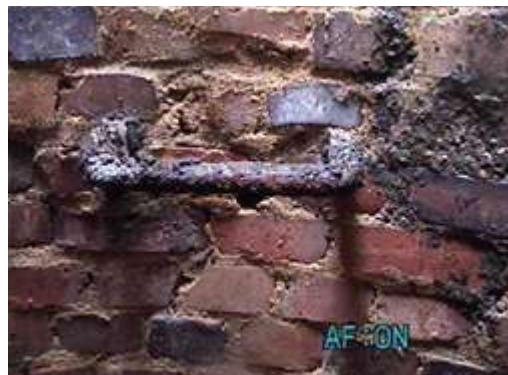
Defect 5

Count: **7** Missing: **0** ☒ **Corroded**

rusted rungs

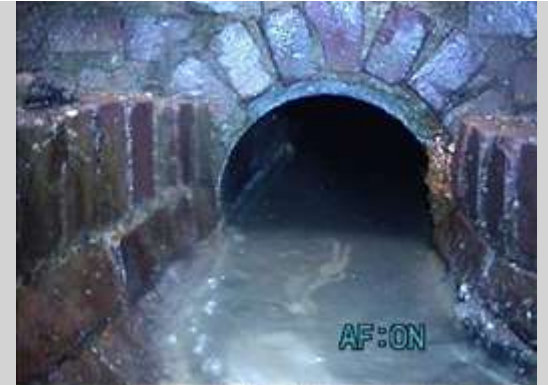
12 O'Clock Outflow

12 in. Circular Gravity Sewer
Pipe Out @ 12 O'Clock

Pipe Height: **12** (in.) Rod and Bar (Angled)
Pipe Material: **Clay** ☐ Pipe Lined
Invert Depth: **12.95** (ft.) Flow Characteristics: **Fast**
Deposits: ☒ None ☐ Mud ☐ Sludge ☐ Debris ☐ Grease
Silt Depth: **0** (in.) Deposits Extent:
Infiltration: **None** Pipe Seal Cond: **Sound**

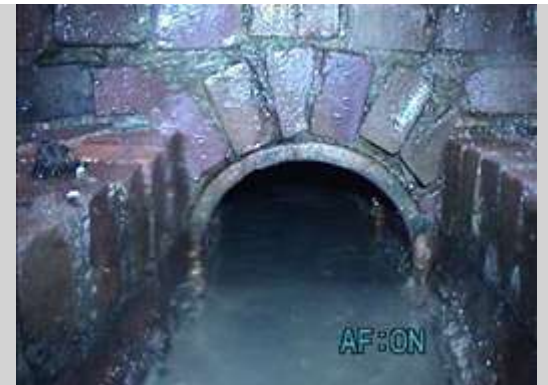
3 O'Clock Inflow

10 in. Circular Gravity Sewer
Pipe In @ 3 O'Clock

Pipe Height: **10.8** (in.) Rod and Bar (Angled)
Pipe Material: **Clay** ☐ Pipe Lined
Invert Depth: **12.58** (ft.) Flow Characteristics: **Slow**
Deposits: ☐ None ☐ Mud ☐ Sludge ☒ **Debris** ☐ Grease
Silt Depth: **3** (in.) Deposits Extent: **Medium**
Infiltration: **Evidence** Pipe Seal Cond: **Unknown**

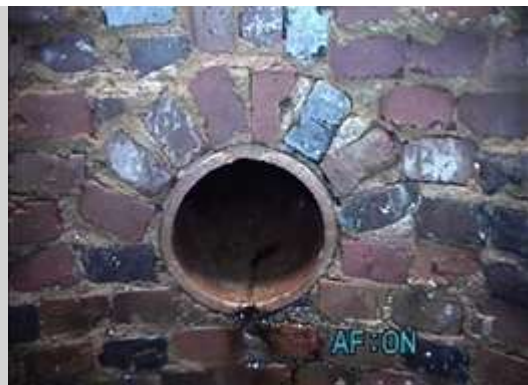
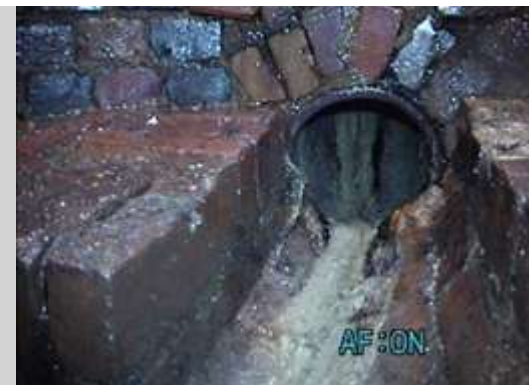
6 O'Clock Inflow

8 in. Circular Gravity Sewer
Pipe In @ 6 OClock

Drop In @ 6 OClock

Infiltration: **Evidence** Pipe Seal Cond: **Unknown**

Drop: Inside	Rod and Bar
Angled: Yes	Reading: 11.73 (ft.)
	Inv Depth: 12.73 (ft.)
Drop Condition: Open
